Picture tube info: This model was available with two different tube neck diameters the same as Wells-Gardner did with the K7000 series. Some versions had a large neck tube (29mm) and some had a small neck tube (22.5mm). The large neck one was Samsung # 51GGB95X-TG (no kidding, that's the number printed on mine). Use B&K rejuvenator adapter CR-23 set to 6.3 volts for heater to test/rejuvenate this tube. The small neck one was Orion # A48JLL90X18. Use B&K rejuvenator adapter CR-31 set to 6.3 volts for heater to test/rejuvenate this tube.

COMPILED BY KEN LAYTON on December 7, 2008

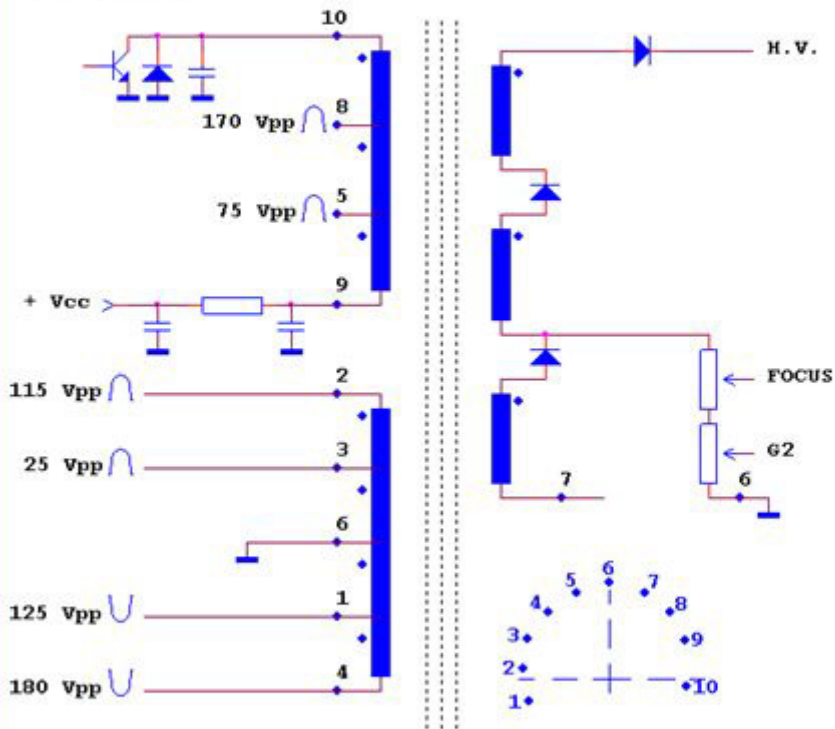
HR 8508

Flyback schematics are courtesy of H.R. Diemen.

INSTRUM.	MAT	+	COL	LA	L1	L2	L3	TYPE
STVDST-01	29.7	9	10	7	6			110

Flyback info: # KFS-60291 (HR Diemen # HR 8508) Bob Roberts stocks this flyback and I'm told that MCM Electronics (www.mcminone) stocks the HR8508 version. Happ Controls # 49-0907-00 (\$45.00). Some versions had a # KFS-60737 (HR Diemen # HR 7199) fly back installed.

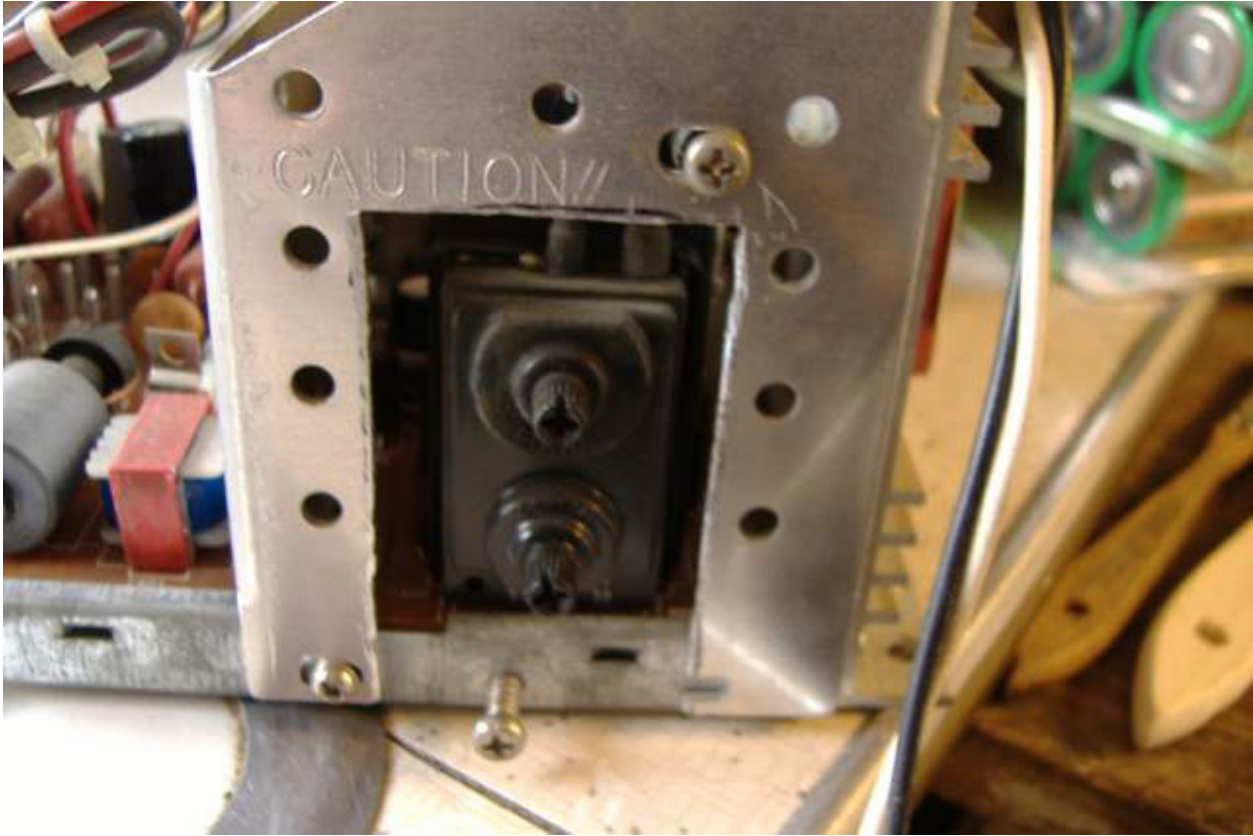
Yoke info: The yellow and green wires are the vertical section and the resistance is 50 ohms. The red and blue wires are the horizontal section and the resistance is 2 ohms. Yoke is SEMCO # DSE-1992NL (used with the Samsung picture tube above). The yoke for use with the small neck tube # A48JLL90X18 is number ODY-M2018.

HOT info: Horizontal output transistor is Q40₂ and is a type 2SD900B. You can sub a 2SD870 or 2SD871 as a replacement. Be advised the transistor's location is silkscreened as "Q40₃" on the component side of the board.

Power supply info: The large chassis mounted power supply regulator transistor (Q601) is a type 2SC2555. The smaller power supply transistors, Q602 (A1091 or NTE288) and Q603 (C2610 or NTE399) have been known to fail. There are several resistors to check in the power supply section for open condition or being off value. Check R612 (5 ohm, 5 watt, and may be marked "509" on it, schematic shows this as R610) which is next to the rear of the flyback metal frame. This resistor will go open circuit if there's a problem in the horizontal output circuit. Check R610 (15k, 1 watt) for a big change in value. If it reads less than 14 k then it's out of

tolerance and must be replaced. Also, resistors R608 and R609 (both are 68 k, 1/4 watt) may open up causing a dead power supply. Resistor R602 is a 330 ohm. The circled areas in the picture are of the resistors that can go bad. Check fuse F602 (1 amp normal blow, 5x20mm size) with an ohmmeter to see if it's bad. This fuse may look good but actually be blown so be sure to use you ohmmeter on it. The soldering job on this chassis leaves alot to be desired. You'll need to look closely and resolder a bunch of joints all over the chassis, but pay particular attention to the power supply section and resistor R611 in the X-Ray protection circuit. **ISOLATION TRANSFORMER REQUIRED.**
